OVERSIGHT SUMMARY K.5
NOVEMBER 2-11, 1997 2/08
FEBRUARY 8-13, 1998

EPA/ARCS V BVSPC Oversight Summary

Reporting Period: November 2 through 11, 1997, and February 8 through 13, 1998

Site Name/Location: American Chemical Services, Inc., Griffith, Indiana

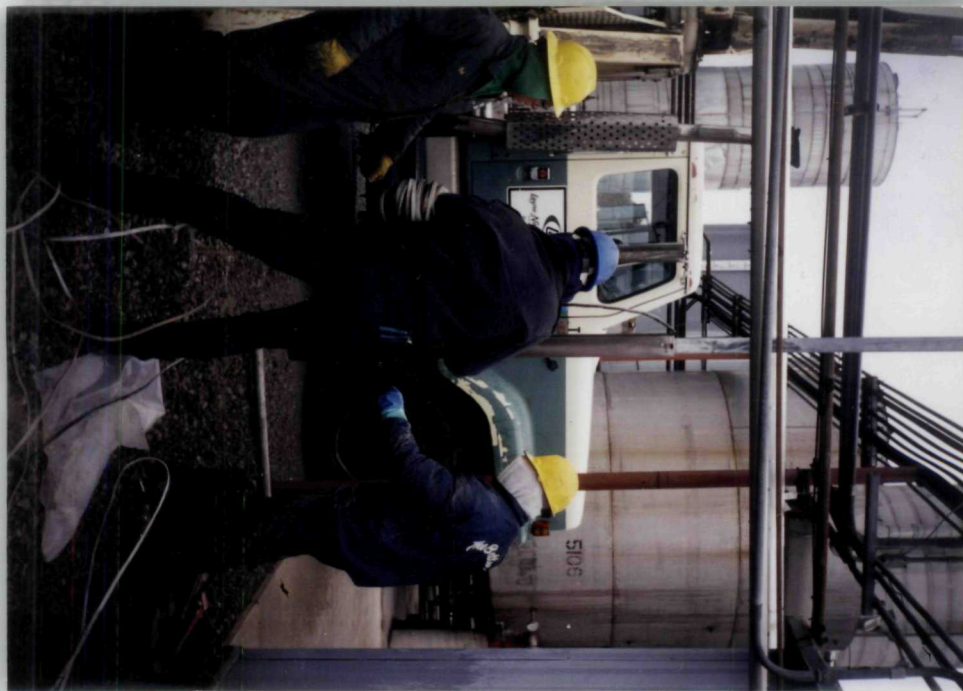
Site: American Chemical Services, Inc. RD/ERA
Proj. #: 46517/46518
Roll: 1 Photo #: 1
Date: 11-02-97 Time: 0905
Photographer: Steve Mrkvicka
Description: Looking north at pump being pulled from IW-3.

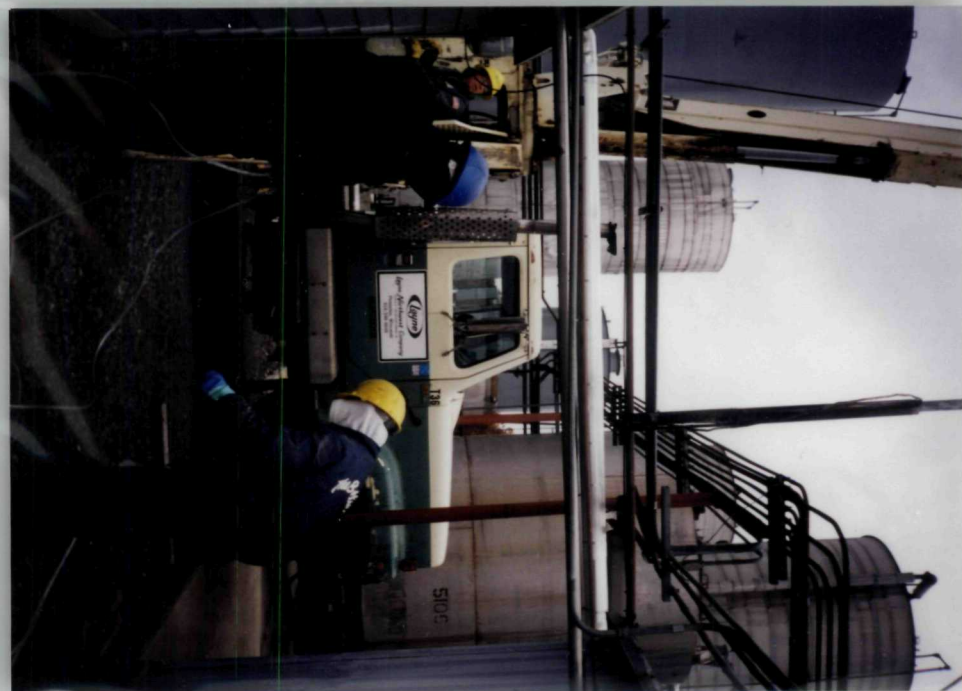
Site: American Chemical Services, Inc. RD/ERA
Proj. #: 46517/46518
Roll: 1 Photo #: 2
Date: 11-02-97 Time: 0905
Photographer: Steve Mrkvicka
Description: Another photo looking north at pump being pulled from IW-3.

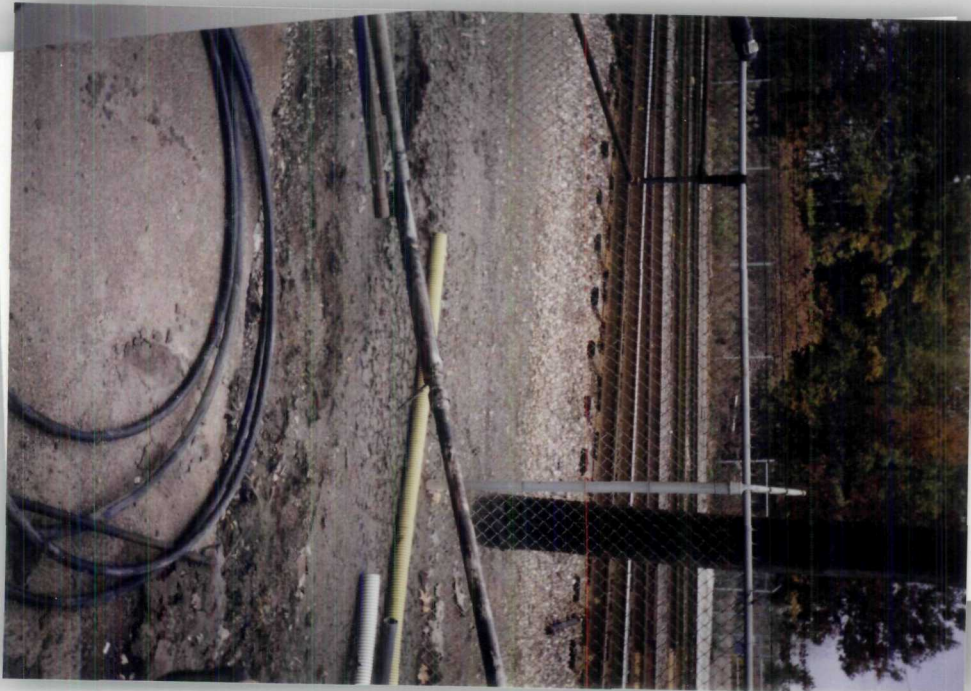
Site: American Chemical Services, Inc. RD/ERA
 Proj. #: 46517/46518
 Roll: 1 Photo #: 3
 Date: 11-02-97 Time: 1005
 Photographer: Steve Mrkvicka
 Description: Looking south at caliper tool installed at IW-3.

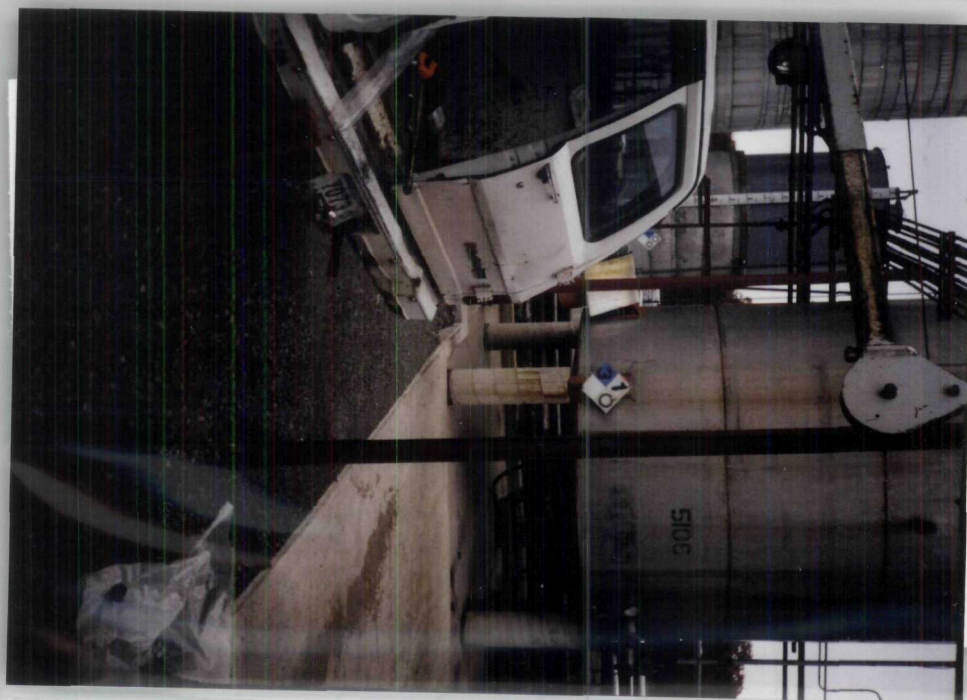
Site: American Chemical Services, Inc. RD/ERA
 Proj. #: 46517/46518
 Roll: 1 Photo #: 4
 Date: 11-02-97 Time: 1105
 Photographer: Steve Mrkvicka
 Description: Looking north at downhole logging at IW-3. Caliper was done first followed by the gamma tool.

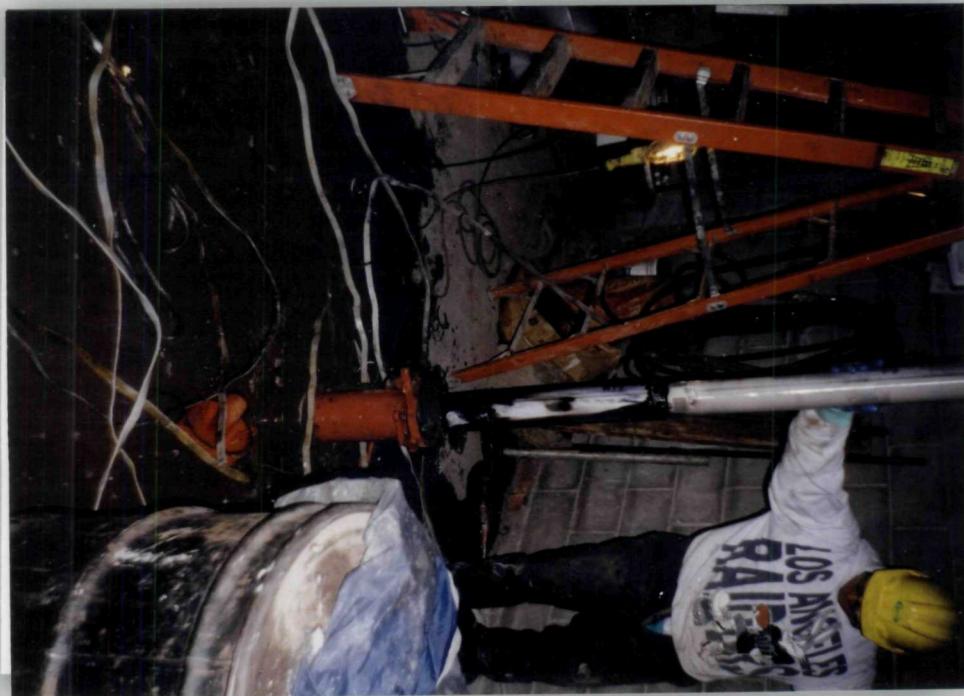
Site: American Chemical Services, Inc. RD/ERA
 Proj. #: 46517/46518
 Roll: 1 Photo #: 5
 Date: 11-02-97 Time: 1115
 Photographer: Steve Mrkvicka
 Description: Pulling pump from IW-2 located inside building.

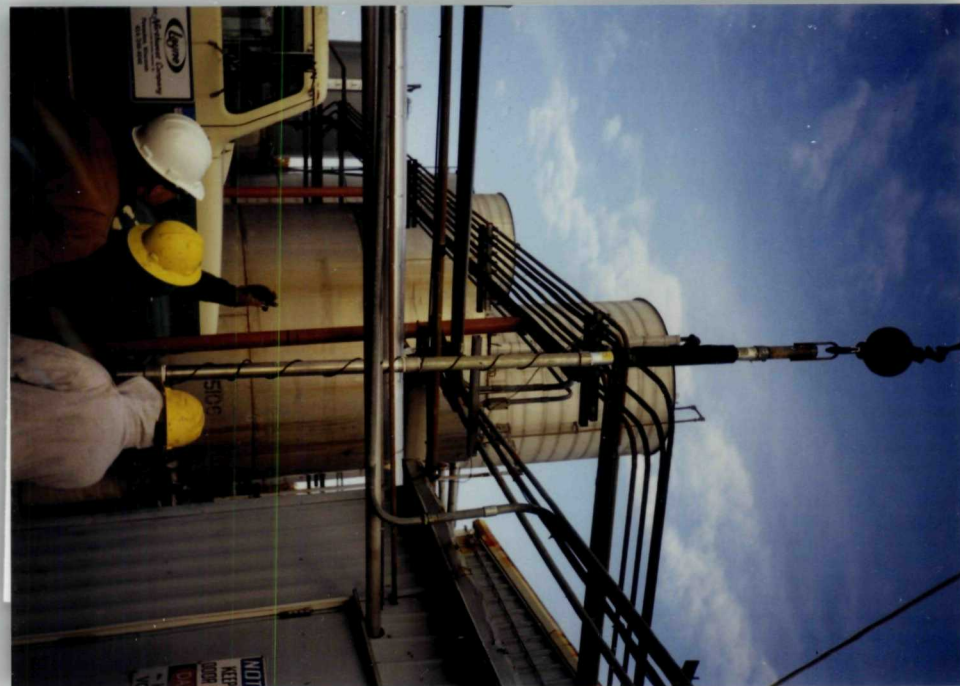
Site: American Chemical Services, Inc. RD/ERA
 Proj. #: 46517/46518
 Roll: 1 Photo #: 6
 Date: 11-02-97 Time: 1515
 Photographer: Steve Mrkvicka
 Description: Looking at packer assembly that is being lowered into IW-3.

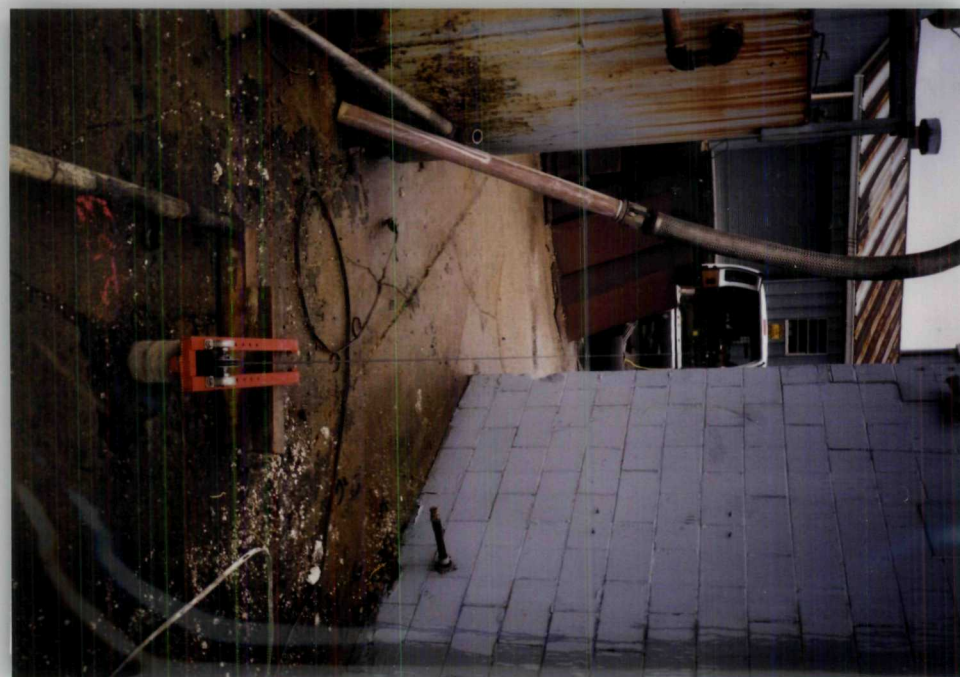
Roll: 1 Photo #: 7

Description: Looking at geophysical logging at IW-1, which is located near railroad tracks at southern end of the active facility or Onsite Containment Area.

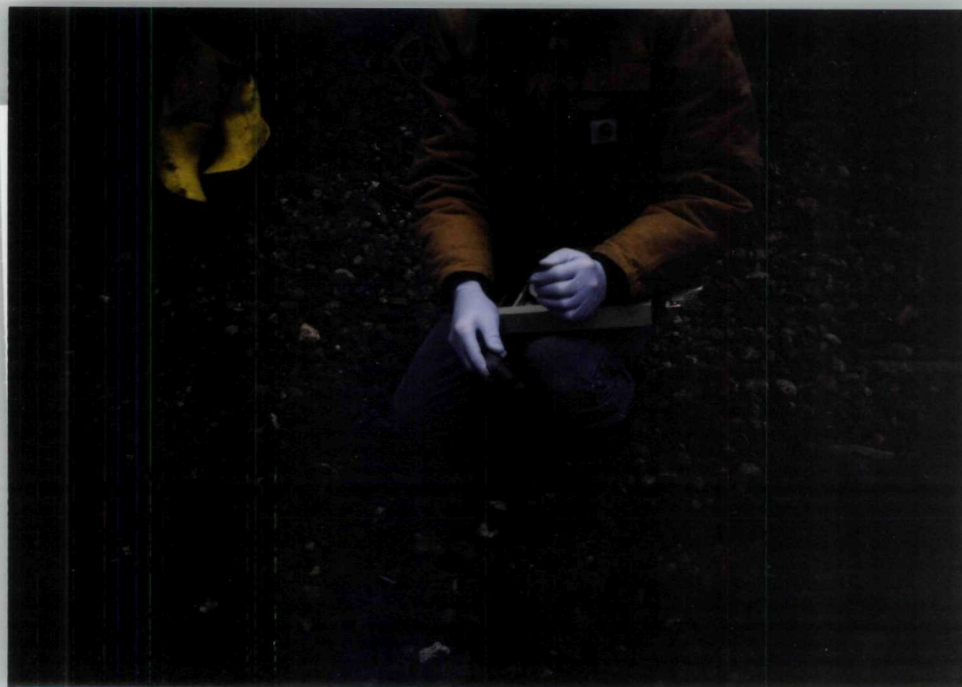
Description: Looking at material at end of a probe that was inserted into IW-5. There was a clay soft obstruction at about 9.9 feet below the top of the well casing.

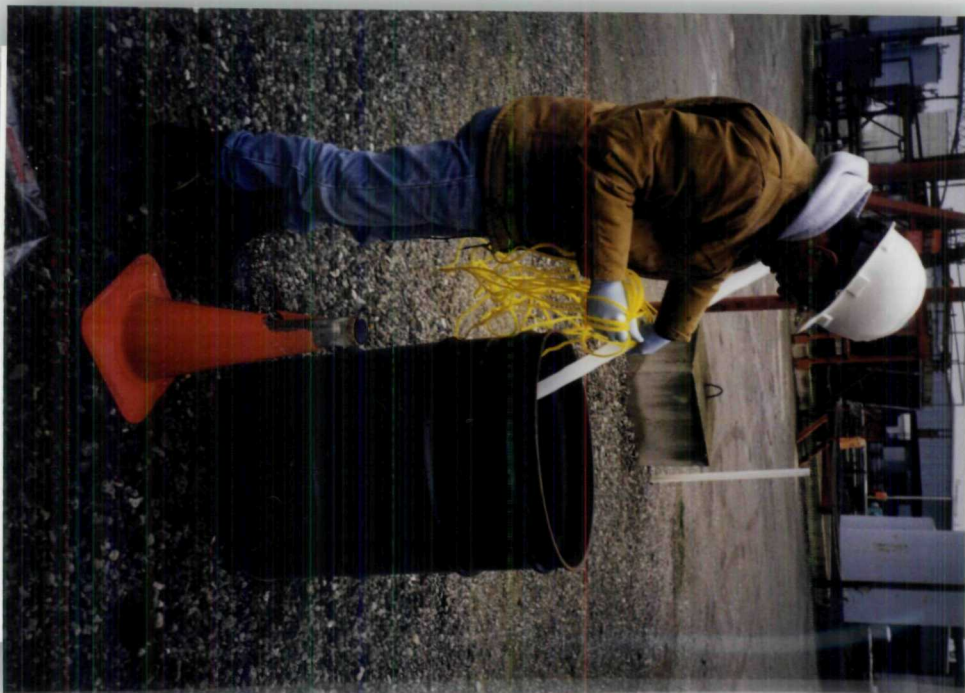
Description: Looking southwest at well purging before sampling at IW-4.

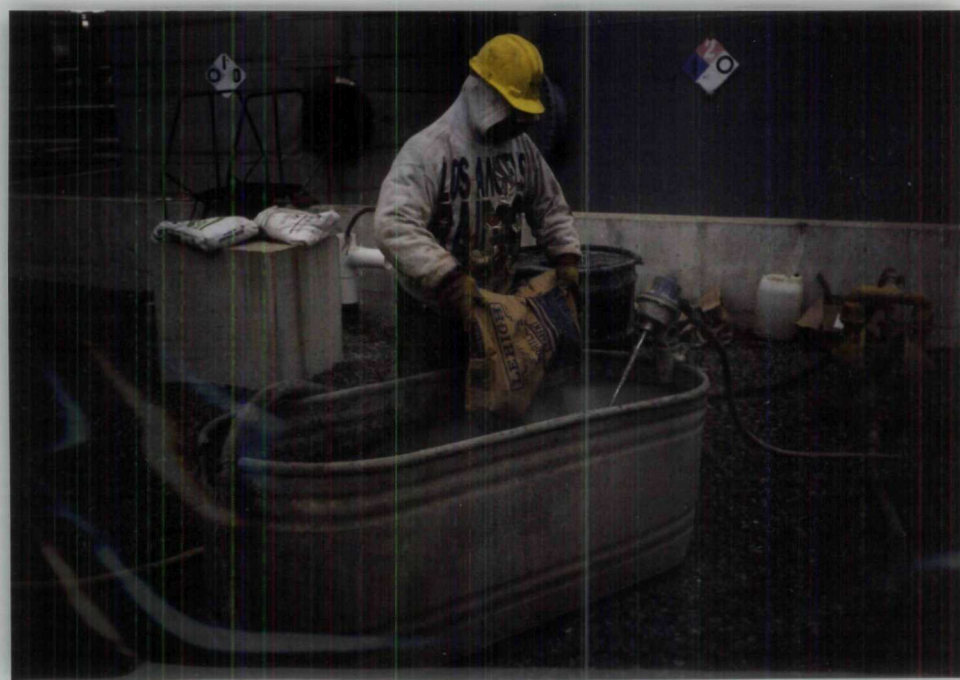
Site: American Chemical Services, Inc. RD/ERA
 Proj. #: 46517/46518
 Roll: 1 Photo #: 11
 Date: 11-04-97 Time: 1350
 Photographer: Steve Mrkvicka
 Description: Looking at bailing of IW-6 before sampling.

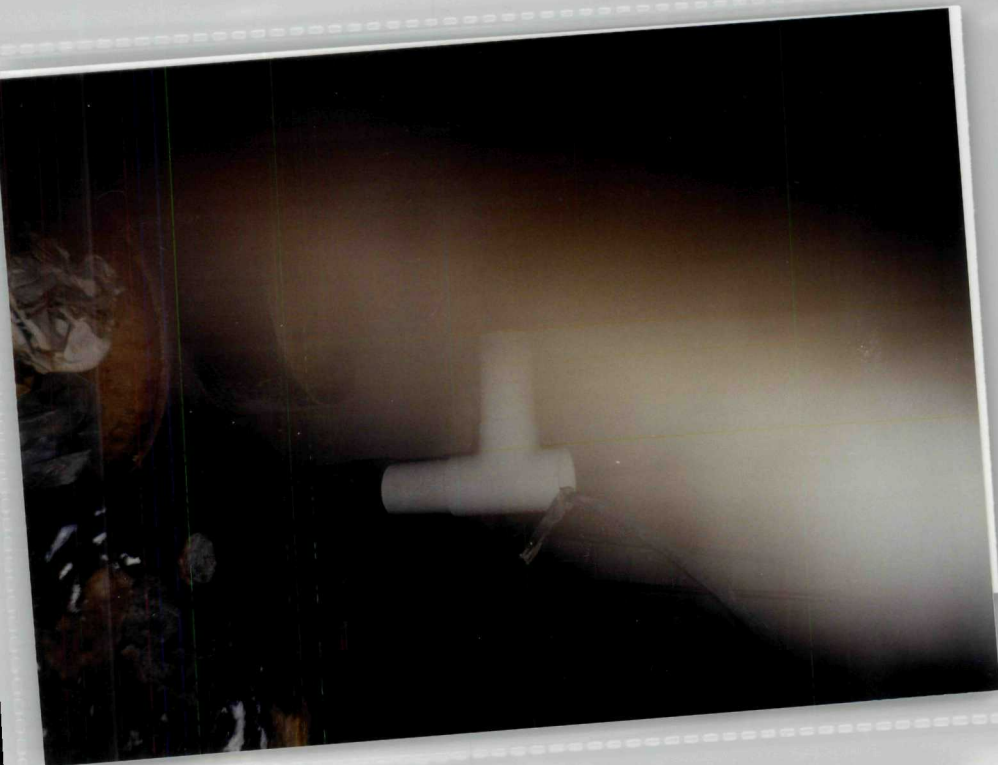
Site: American Chemical Services, Inc. RD/ERA
 Proj. #: 46517/46518
 Roll: 1 Photo #: 13
 Date: 11-07-97 Time: 1100
 Photographer: Steve Mrkvicka
 Description: Grout is pumped into IW-2.

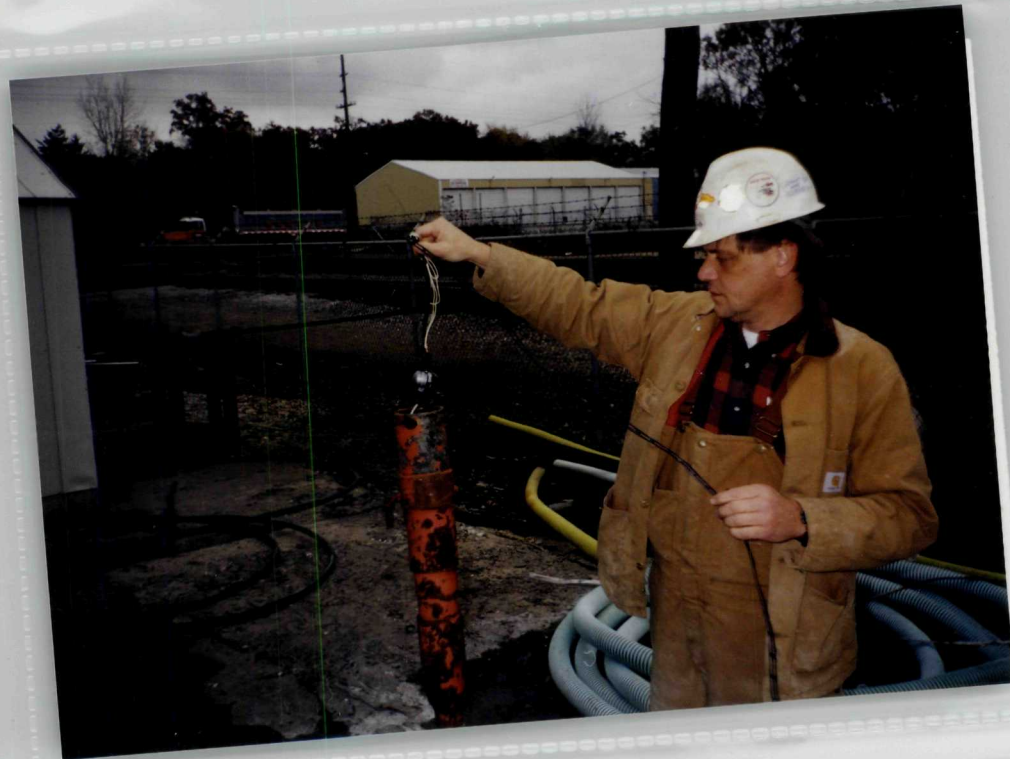
Site: American Chemical Services, Inc. RD/ERA
 Proj. #: 46517/46518
 Roll: 1 Photo #: 14
 Date: 11-08-97 Time: 0840
 Photographer: Kevin Brown
 Description: Perforating jet with detonator about to go into IW-1.

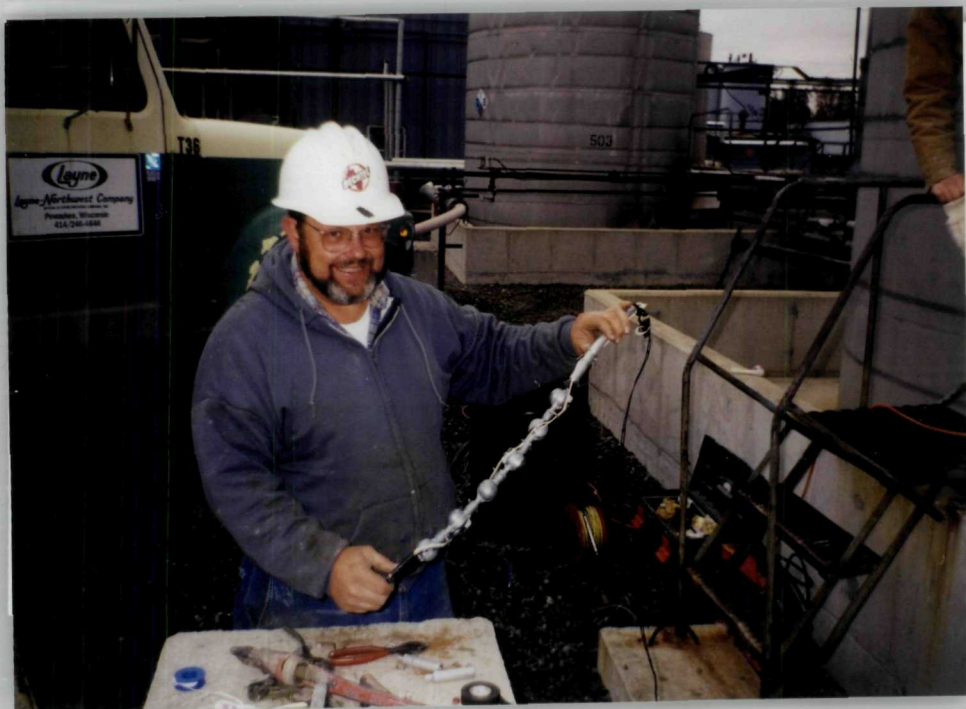
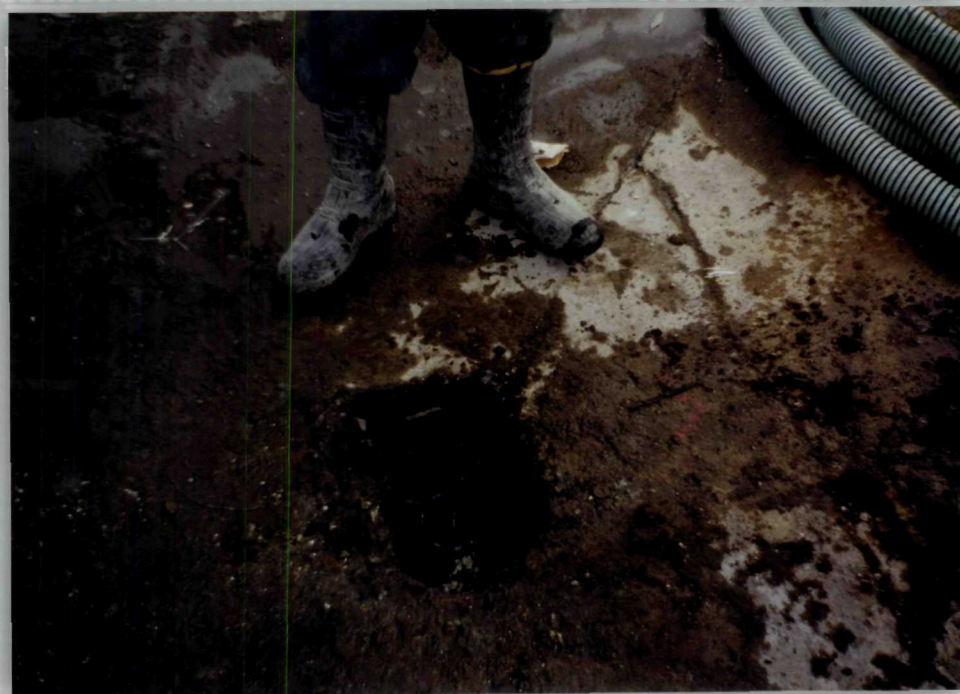
Site: American Chemical Services, Inc. RD/ERA
 Proj. #: 46517/46518
 Roll: 1 Photo #: 15
 Date: 11-08-97 Time: 1430
 Photographer: Kevin Brown
 Description: Material coming up from IW-1. Crew circulates water through perforations to clean out coarse materials such as sand and rock.

Site: American Chemical Services, Inc. RD/ERA
 Proj. #: 46517/46518
 Roll: 1 Photo #: 16
 Date: 11-08-97 Time: 1430
 Photographer: Kevin Brown
 Description: Another photo of the material coming up from IW-1. Crew circulates water through perforations to clean out coarse materials such as sand and rock.

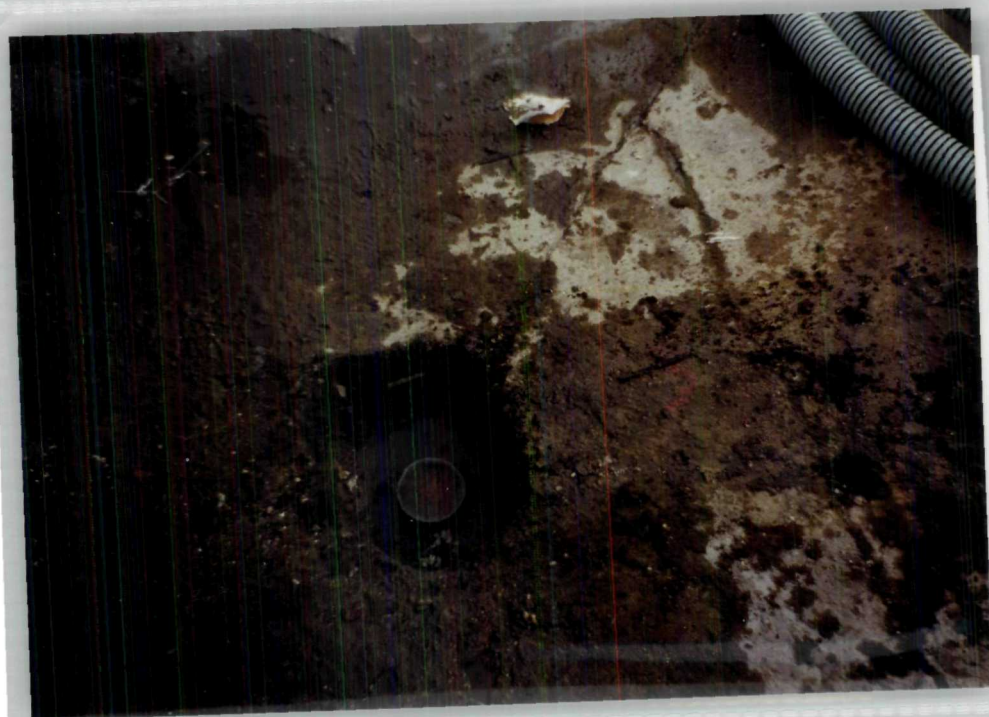
Site: American Chemical Services, Inc. RD/ERA
 Proj. #: 46517/46518
 Roll: 1 Photo #: 19
 Date: 11-11-97 Time: 1255
 Photographer: Kevin Brown
 Description: Looking at cap on casing at IW-1 before being welded on.

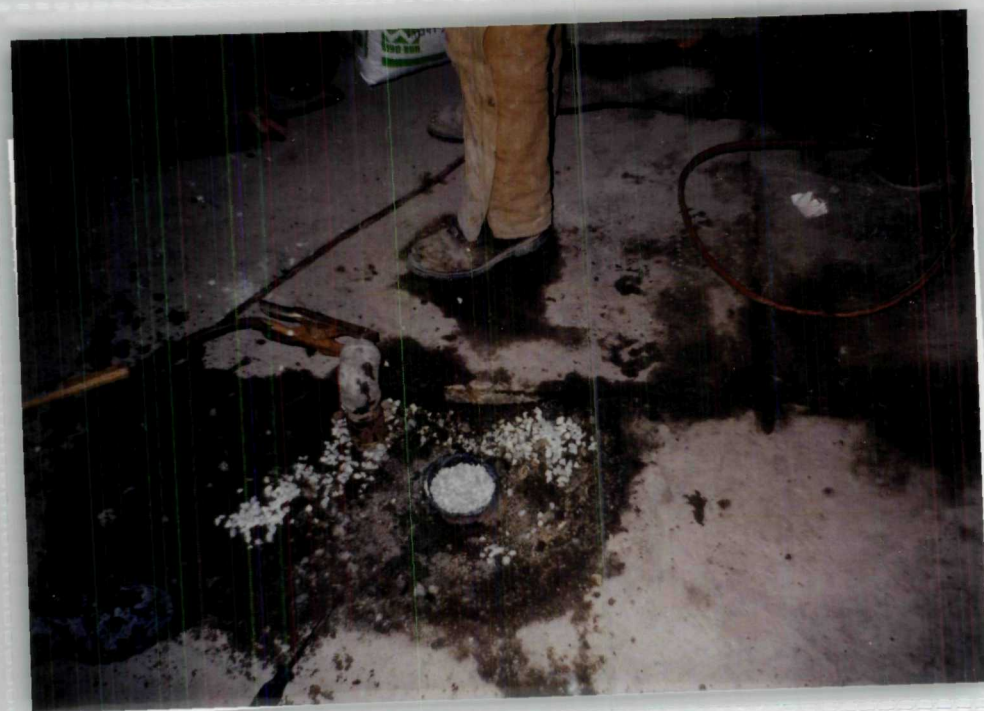
Site: American Chemical Services, Inc. RD/ERA
 Proj. #: 46517/46518
 Roll: 1 Photo #: 20
 Date: 11-11-97 Time: 1330
 Photographer: Kevin Brown
 Description: Looking at IW-2 casing, which is cut off at about 4 inches below the floor slab. IW-2 is located inside a boiler room. Bentonite pellets were added into the well. Two inch pipe located about 4 inches northwest of IW-2 is cut off about 3 inches below floor slab.

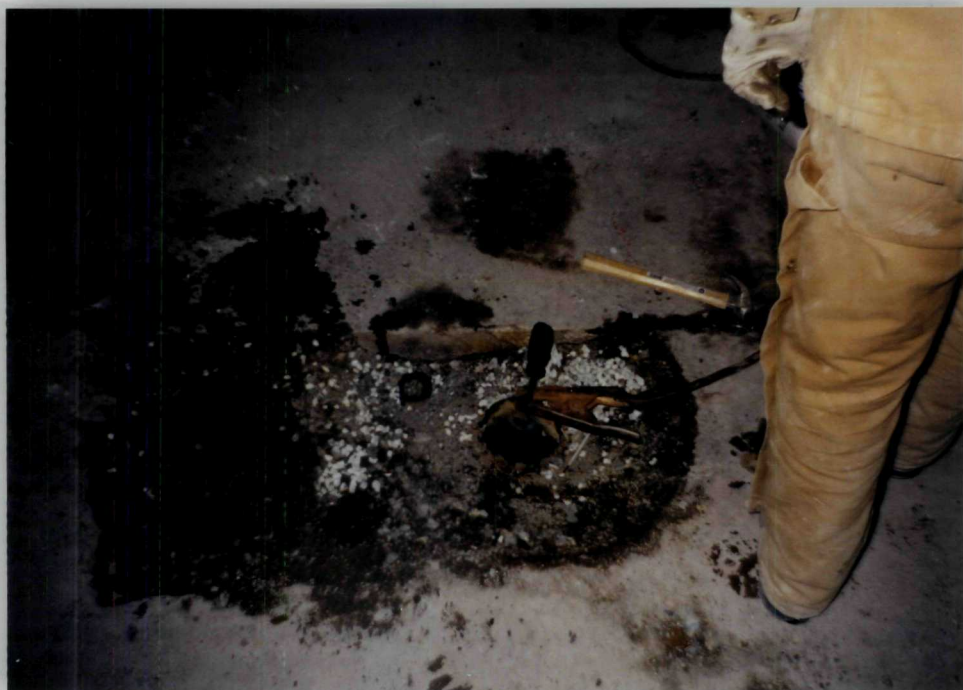
Site: American Chemical Services, Inc. RD/ERA
 Proj. #: 46517/46518
 Roll: 1 Photo #: 21
 Date: 11-11-97 Time: 1340
 Photographer: Kevin Brown
 Description: Cap being welded onto IW-2 casing.

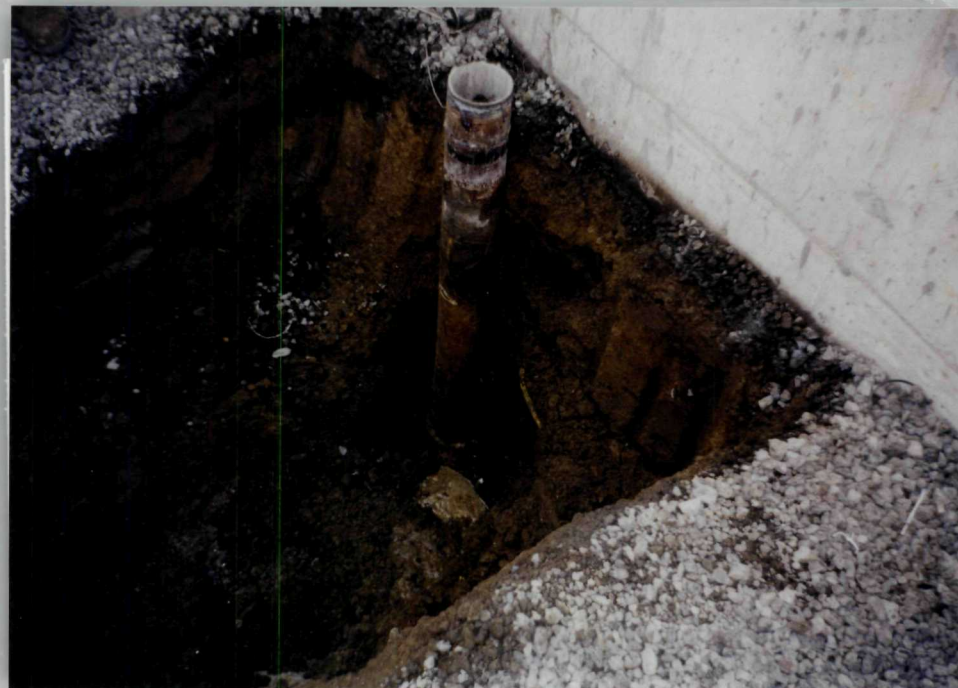
Site: American Chemical Services, Inc. RD/ERA
 Proj. #: 46517/46518
 Roll: 1 Photo #: 22
 Date: 11-11-97 Time: 1415
 Photographer: Kevin Brown
 Description: Looking at IW-4 well casing. Backhoe used to excavate around casing to a depth of about 4 feet below ground surface. Note 2 inch PVC line coming into the well from the north. Casing had been sealed above entry point of the 2 inch line.

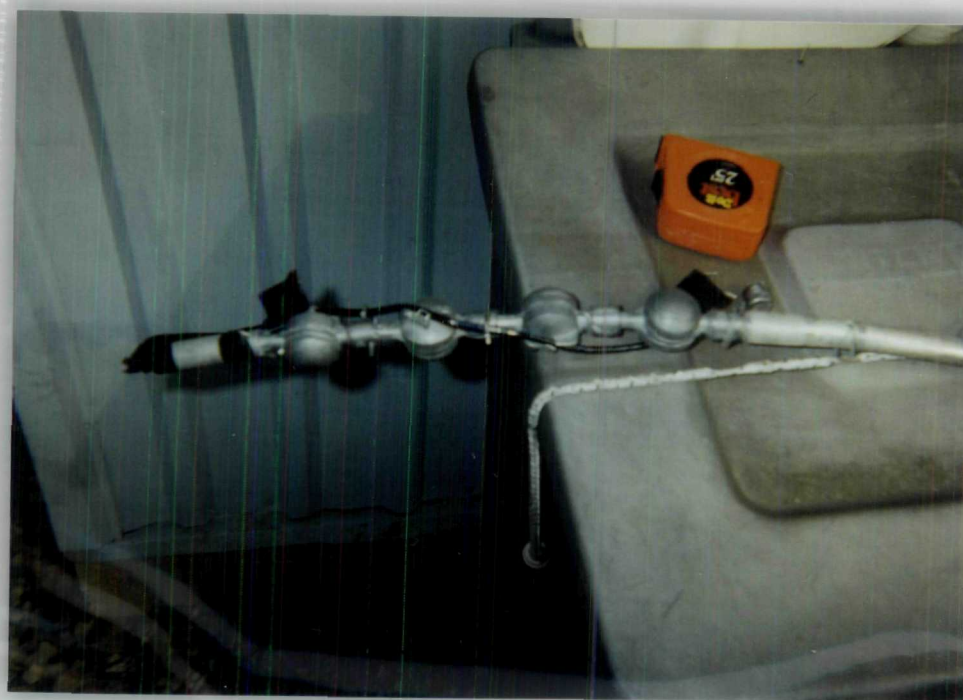
Description: Close-up view of the string of four plastic explosive charges to be detonated at 36 feet below land surface (bls) in IW-3 (for perforation of 2 inch well riser/casing).

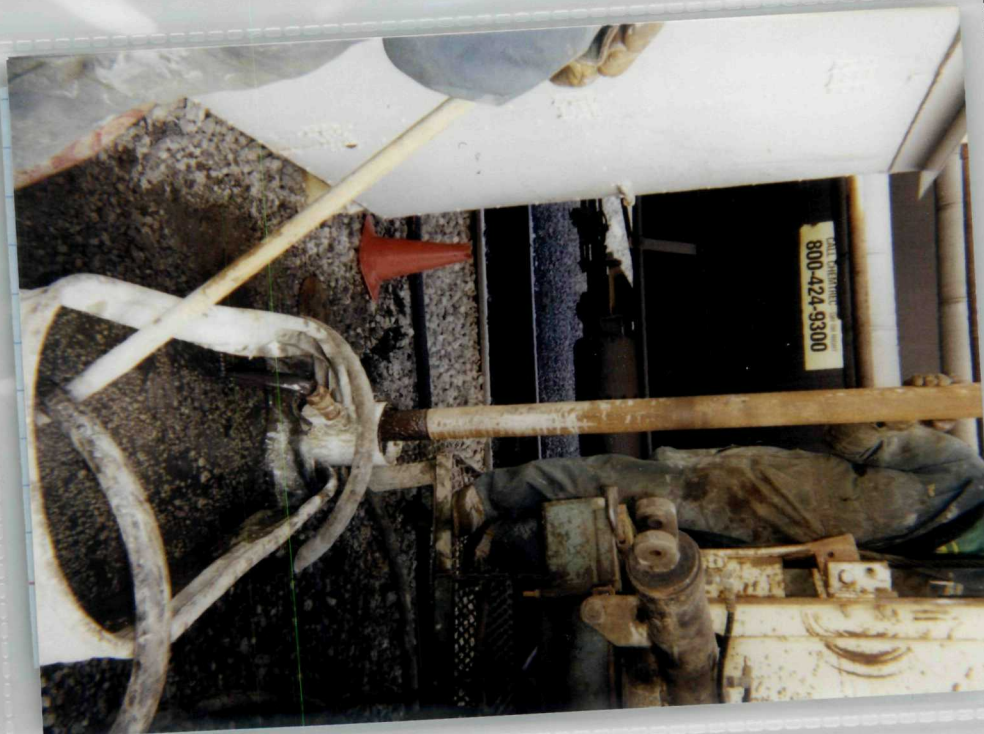
Site: American Chemical Services, Inc. RD/ERA
 Proj. #: 46517/46518
 Roll: 1 Photo #: 5
 Date: 2-08-98 Time: 1150
 Photographer: Carter Helm
 Description: Closeup view of the detonator device and fire wire used by Layne drillers to set off charges down hole.

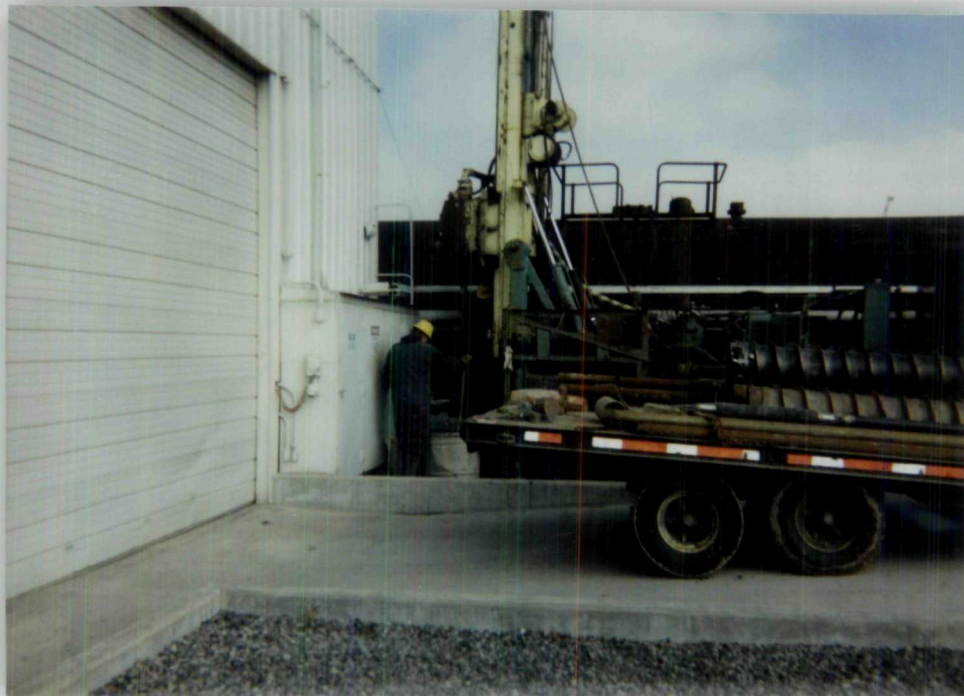
Site: American Chemical Services, Inc. RD/ERA
 Proj. #: 46517/46518
 Roll: 1 Photo #: 6
 Date: 2-08-98 Time: 1205
 Photographer: Carter Helm
 Description: North view of drillers using a 3 inch core barrel to overdrill the existing well at IW-5. Rotary wash method is being utilized. Circulation using mud tub in foreground.

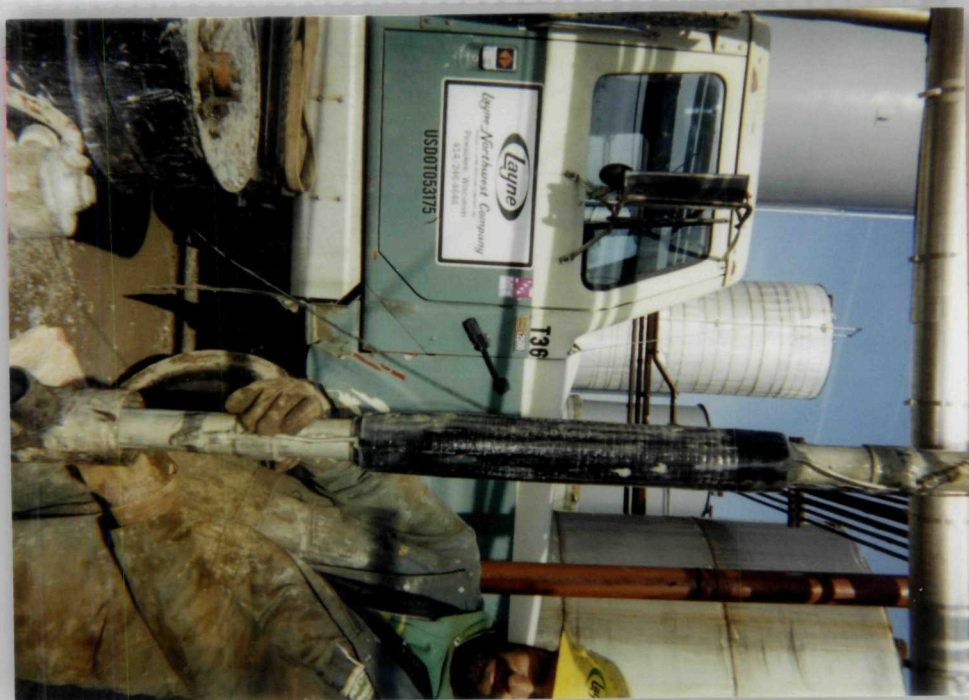
Description: North view of the packer assembly after it was extracted from IW-3. The packer is inflated using nitrogen gas for a tight seal within the casing.

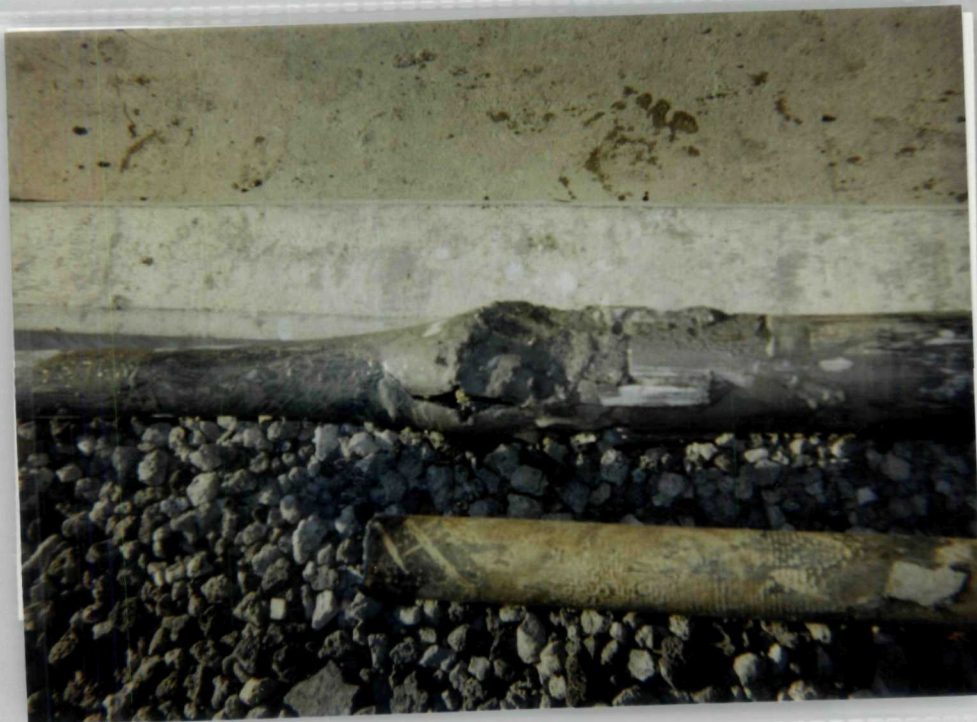
Description: Close-up view of the perforation created by the plastic explosive at 63 feet bls in IW-5. Unfortunately, the explosion expanded the 2 inch well bigger than the 3 inch core barrel that the well was to be extruded from (through). This is the reason the well could not be pulled through the 3 inch core casing surrounding it.

The use of plastic explosives to create perfs in well casing can be guess work as far as what exactly happens downhole. These perfs are supposed to create 0.5-inch holes with no pipe expansion; however, if the explosive is placed near the well seam or a well defect or area of weakness, as was the case at IW-5, casing expansion hinders the well abandonment process. For future well abandonment at IW-6, BVSPC recommends use of 1-inch pipe to collapse the bottom of the well to establish circulation, and if that fails, then use explosives. Michael Hirt, Montgomery Watson geologist, agreed. A delay of approximately 4 hours occurred at IW-5 due the unpredicted expansion of the well casing due to an uncontrolled perf.

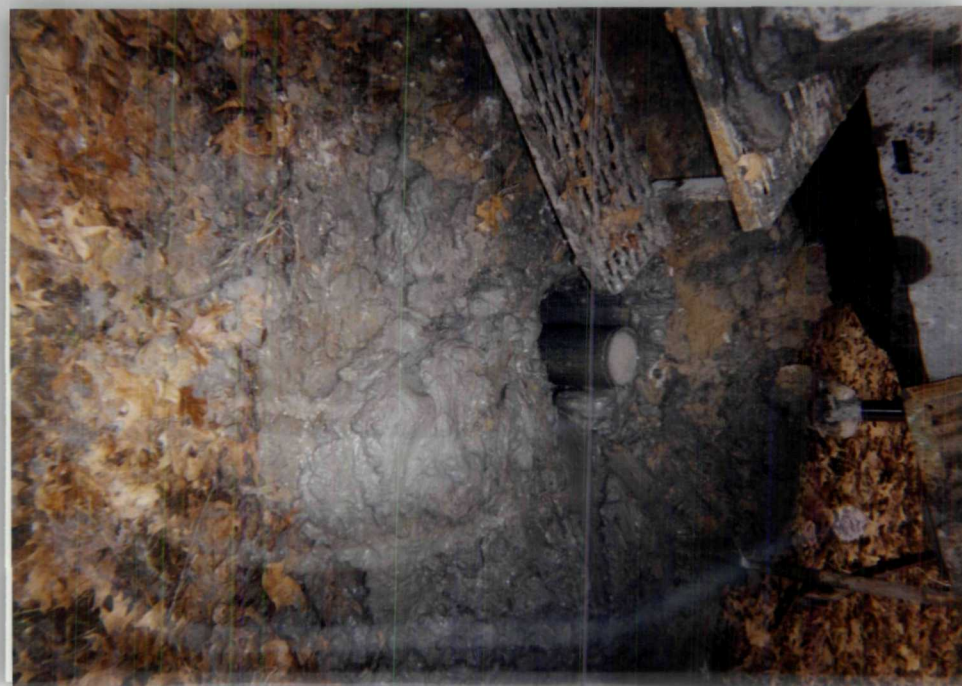
Description: A close up view of the recently grouted 6 inch surface casing for MW-9R. A minimum 24-hour wait period ensues prior to drilling to continue (through clay layer and into the lower aquifer).

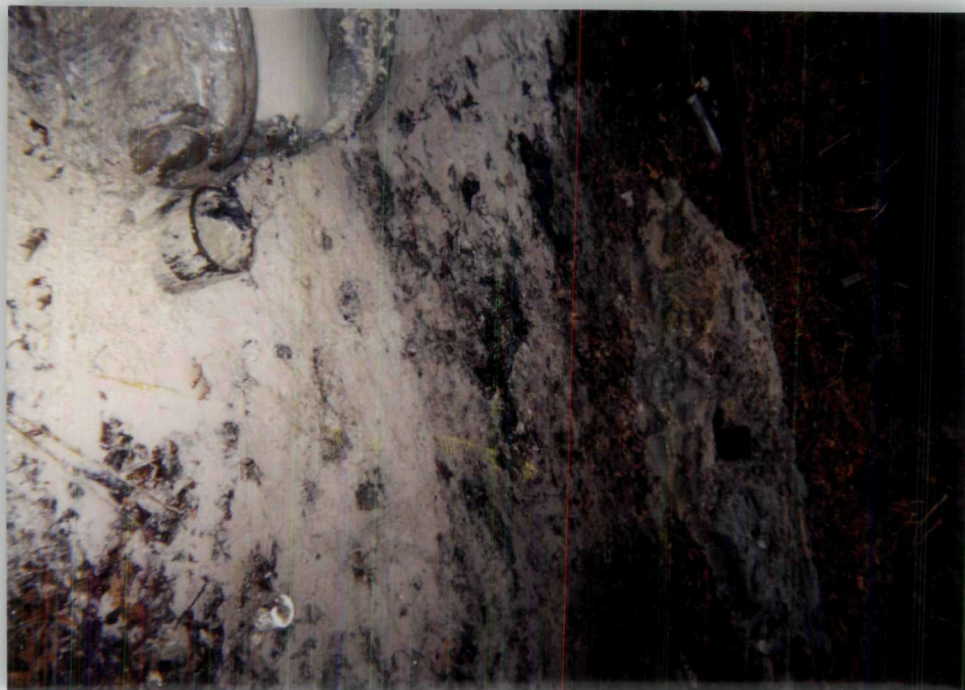
Description: South view of two surface casings, foreground casing is for the new MW-9R; background casing is the former MW-9 casing soon to be abandoned.

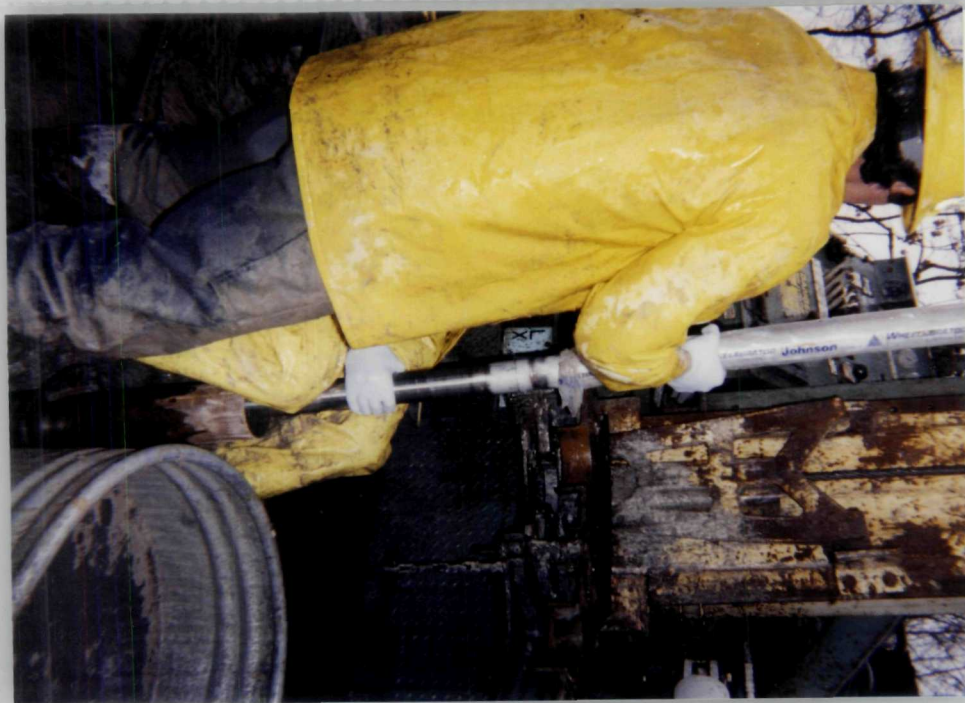
Site: American Chemical Services, Inc. RD/ERA
 Proj. #: 46517/46518
 Roll: 1 Photo #: 21
 Date: 2-11-98 Time: 1605
 Photographer: Carter Helm
 Description: Close up view of drillers assembling the new MW-9R prior to sand pack placement. This well was set at 37 feet bls.

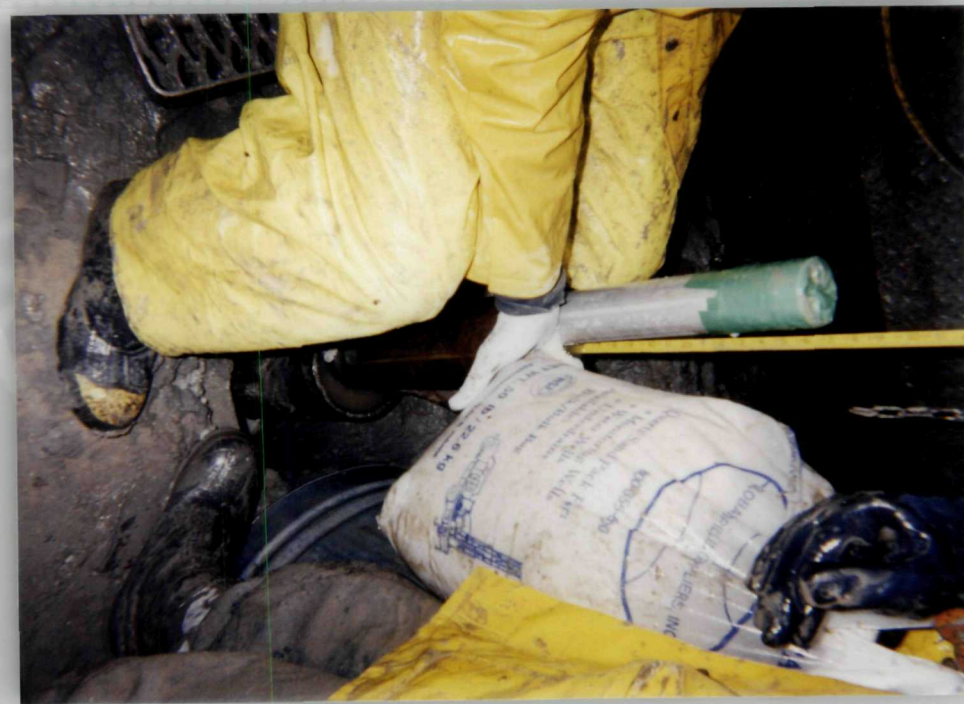
Site: American Chemical Services, Inc. RD/ERA
 Proj. #: 46517/46518
 Roll: 1 Photo #: 22
 Date: 2-11-98 Time: 1625
 Photographer: Carter Helm
 Description: Close up view of the construction of MW-9R. Here the sand pack is slowly poured to avoid bridging of sand, Global brand, #5 sized sand was used. Top of sand pack was measured to 24.8 feet bls, 2.2 feet above the top of the screen satisfying SOP directives. Notice the constant use of a down hole tape measure (yellow in photo), drillers always knew where the top of their well materials lie, and could avoid bridging.

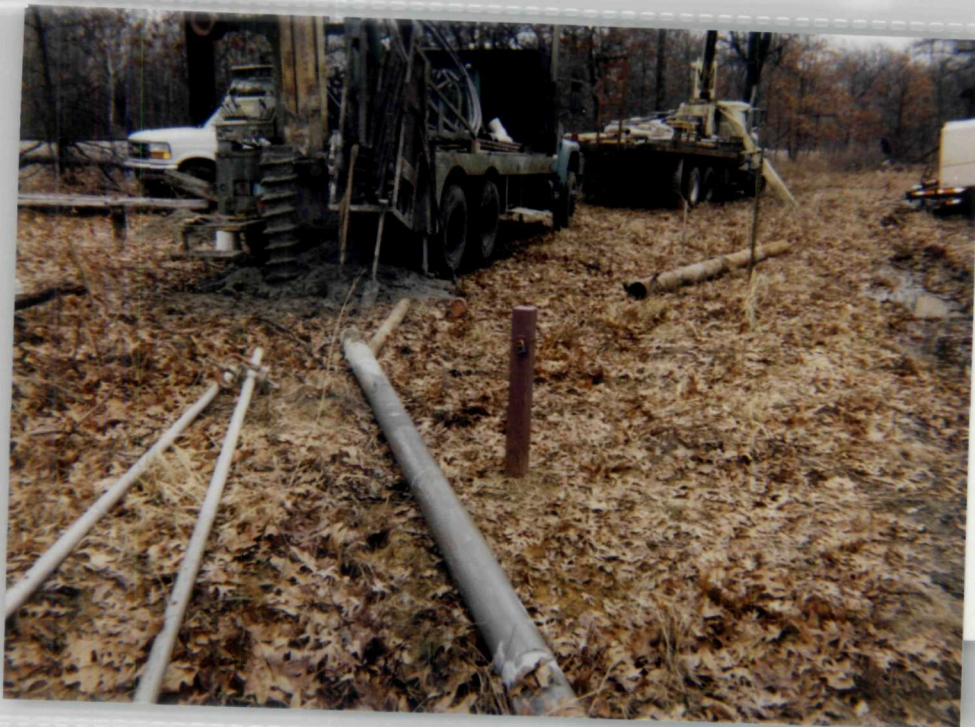
Description: Northeast view of hollow stem augers in MW-54's borehole just after the 6-inch surface casing was extracted and before its replacement with an 8-inch outer surface casing, closely following the MW-54 well abandonment SOP guidelines. Scattered in the foreground is the remaining is the former MW-54 well screen and riser (on left) to be later decontaminated and reused for MW-54R, and the extracted 6-inch surface casing (center and right).

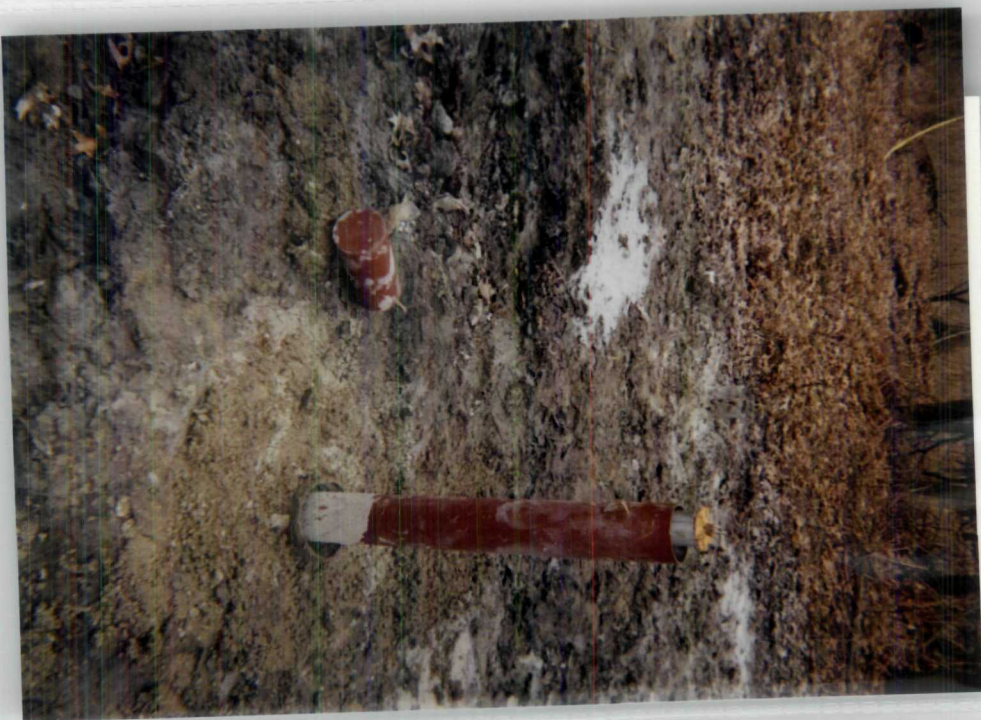
Description: Southwest view of the recently installed protective outer casing at surrounding the MW-9R monitoring well. The well was subsequently secured using a padlock.

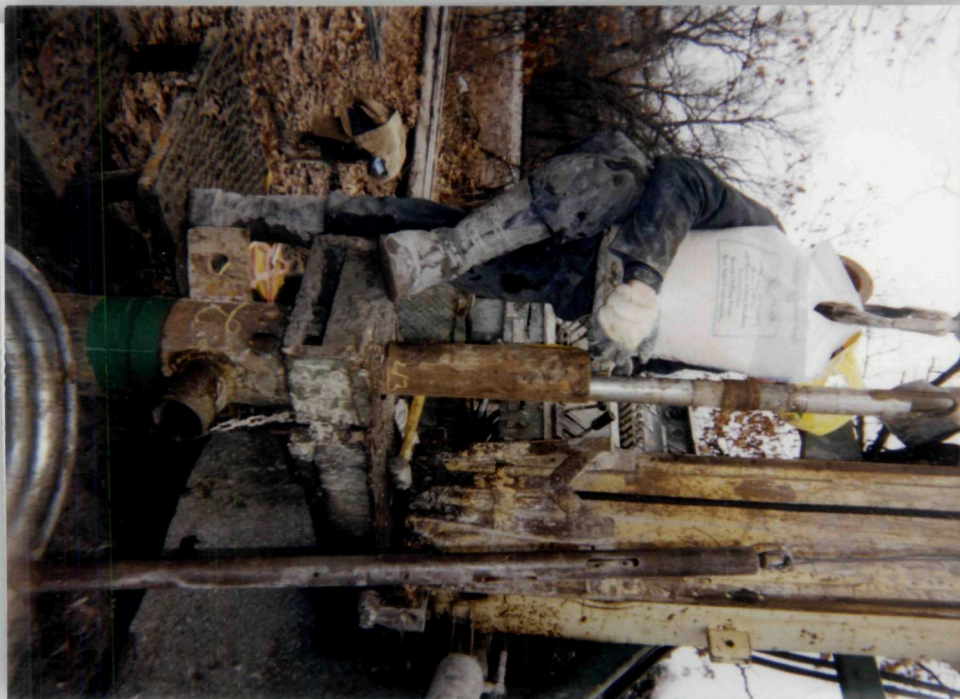
Description: North view of drillers constructing MW-54R prior to the sand pack placement around its 10-foot stainless steel screen.
